Case Study: Fish Hatchery Reline

**COMPLETE RELINE OF 53 PONDS IN LESS THAN 200 CALENDAR DAYS
FOR TEXAS PARKS AND WILDLIFE DEPARTMENT**

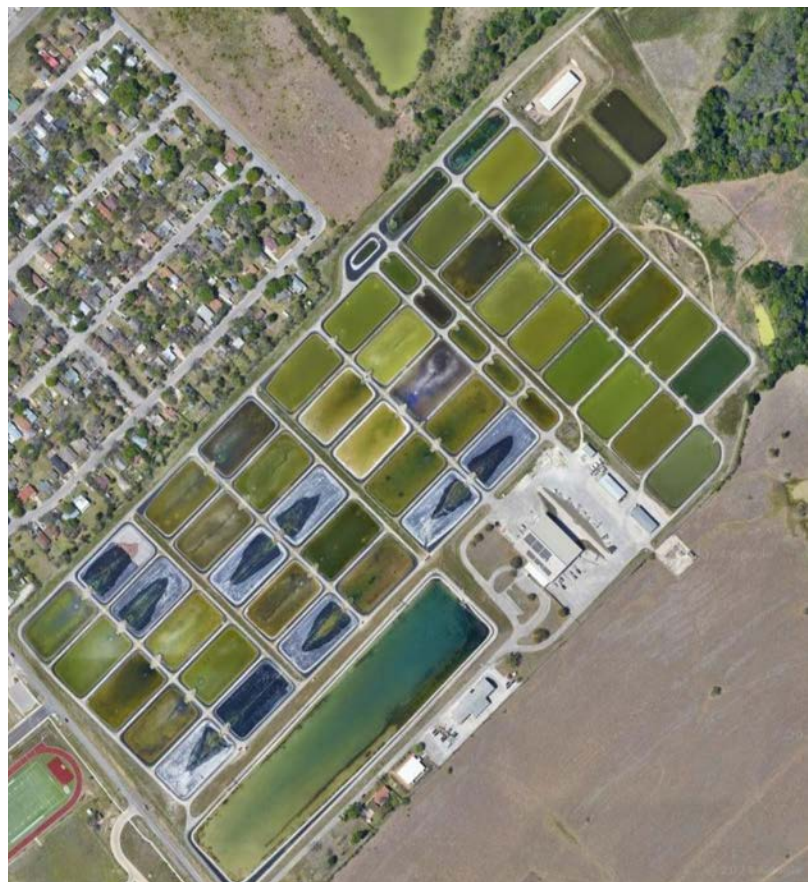
Having worked with TPWD to reline several ponds damaged during the freeze of 2018, and 22 ponds at its Sea Center location in 2022, the Mustang Extreme team fully understood the critical nature of the project, the schedule, and the need for the highest quality products and installation standards.

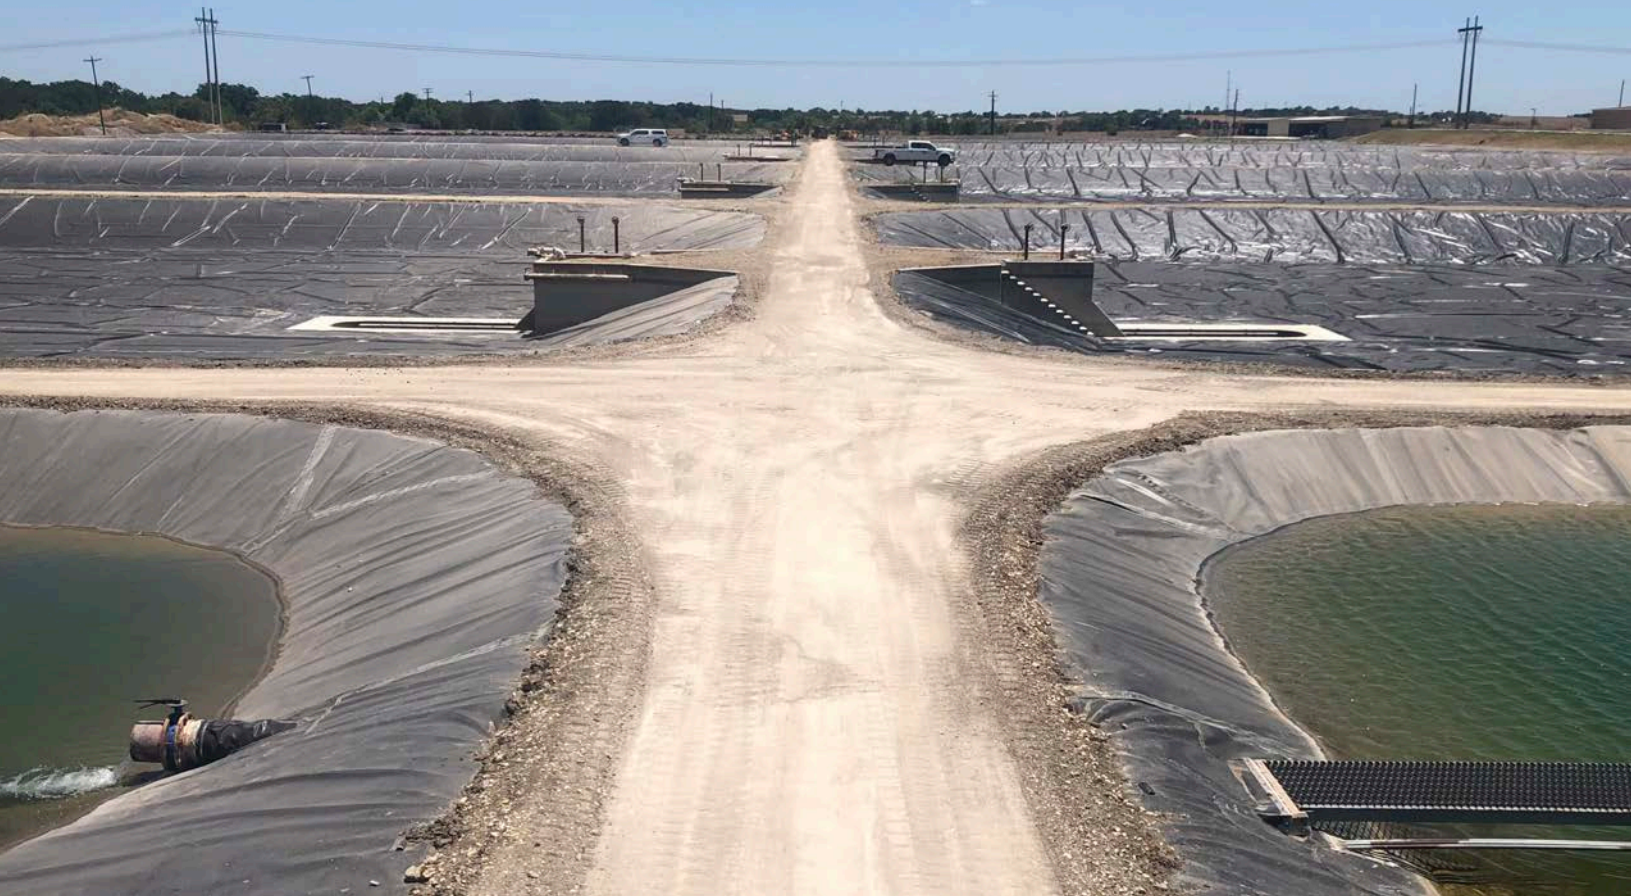
Critical Requirements

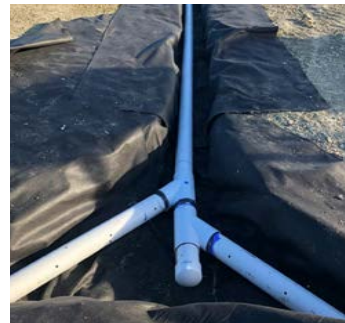
Perforated PVC pipe installed underneath the pond.
